Thomas Fire Recreation BAER Report

Phase 2 (Santa Barbara & Backcountry Parts) – LPF

Fire Name: Thomas

Month and Year: January 2018

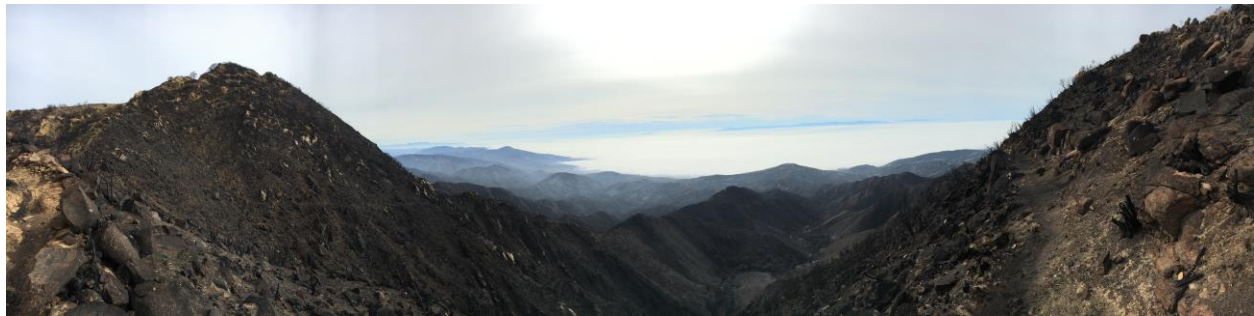
Franklin Trail, January, 2017

- e. Franklin Trail (25W09): This trail has had limited pre-fire maintenance of existing water drainage features. These pre-existing risks to the trail will be exacerbated by post-fire conditions. Therefore, post-fire storm inspections and emergency repairs are required in order to maintain the existing capital investment.
